# Front Inner Hinge Pillar Sectioning

## Removal Procedure

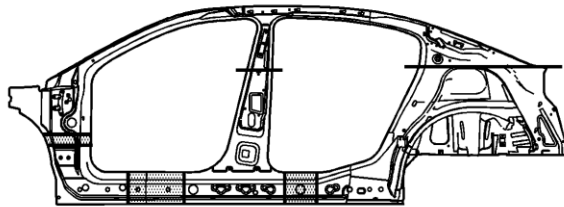
The full body side inner panel comes as a one-piece assembly and can be replaced at the factory seams after removal of the outer panels, the roof panel and the front and rear window, any of these sectioning procedures can be performed separately or in any combination, depending on the extent of the damage to the vehicle.

**Caution:** Sectioning should be performed only in the recommended areas. Failure to do so may compromise the structural integrity of the vehicle and cause personal injury if the vehicle is in a collision.

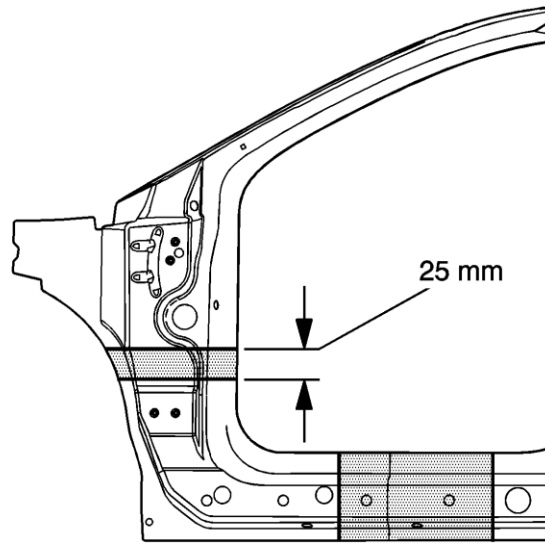
6. Locate and mark a horizontal line 25 mm (1 in) down from the raised square portion of the hinge pillar. This will be the cut location.
7. At the rocker panel, locate and mark a vertical cut line in the approved sectioning location.
8. Cut at the 2 marked locations.

**Important:** Do not damage any inner reinforcements or panels.

**Important:** Cut through only one layer of metal.

9. Locate and drill out the factory welds, noting the number and the location of the welds.

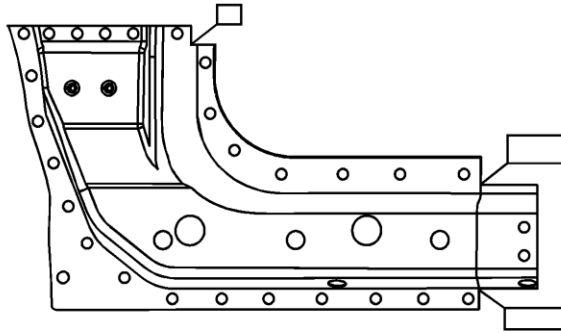
1. On the hinge pillar, scribe a cut line 50 mm (2 in) above the raised square portion of the hinge pillar. This will create a 25 mm (1 in) overlap on the service part.
2. Notch the panel on the door weatherstrip flange to prevent excessive metal thickness in this area.
3. In the rocker area, locate and mark a cut line in the recommended sectioning area. Allow for a 50 mm (2 in) overlap to the vehicle sectioning areas.

4. Cut along the marked sectioning lines to create the service part.
5. Notch the panel on the door weatherstrip flange to prevent excessive metal thickness in this area.

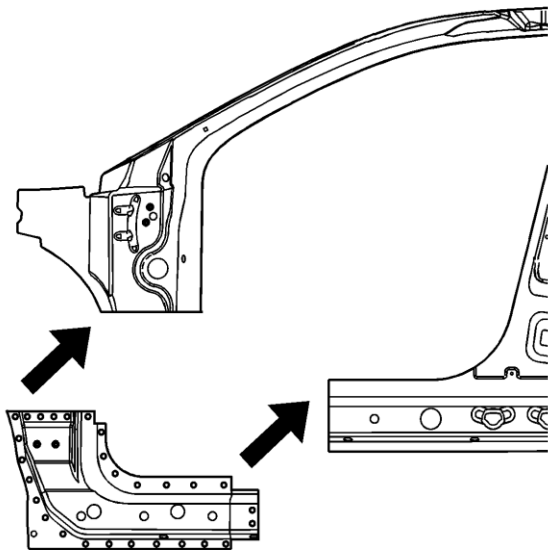
6. Note the number and the location of the factory welds for installation of the service part.

**Important:** If the location of the original plug weld holes cannot be determined, or if structural weld-thru adhesive is present, space the plug weld holes every 40 mm (1½ in).

7. Drill 8 mm (5/16 in) plug weld holes in the service part as necessary as noted from the original panel.
8. Drill additional plug weld holes 13 mm (1/2 in) in from the seam weld.
9. Prepare all mating surfaces as necessary.

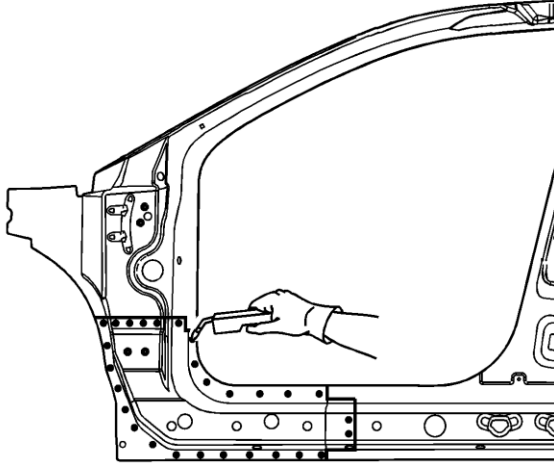
12. Plug weld accordingly.
13. Weld and grind the seam.
14. Refinish and paint the repaired area. Refer to [Basecoat/Clearcoat Paint Systems](#) .
15. Install all of the related panels and components.
16. Connect the negative battery cable. Refer to [Battery Negative Cable Disconnection and Connection](#) .
17. Enable the SIR system. Refer to [SIR Disabling and Enabling](#) .
