## Front Compartment Inner Side Rail Sectioning

### Removal Procedure

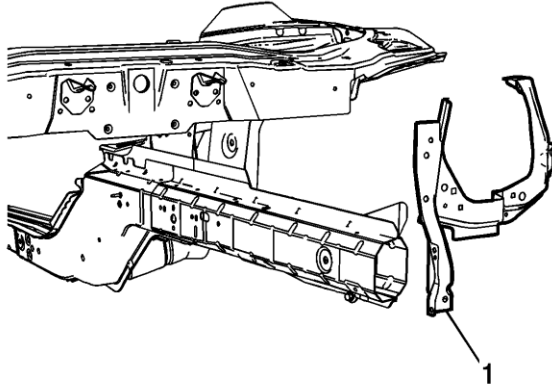
6. Remove Upper Tie Bar Reinforcement (1).

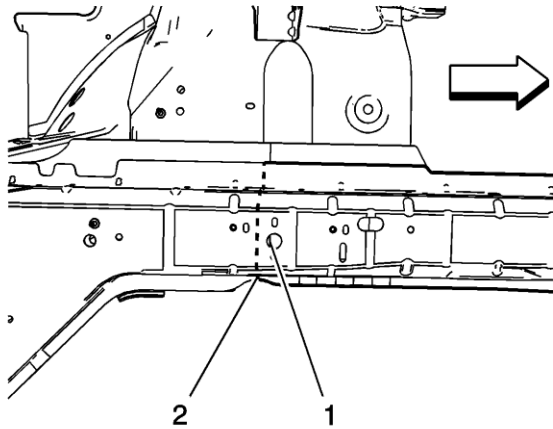
7. Measure 13 mm rearward from 21 mm gage hole (1) and scribe a horizontal line (2).

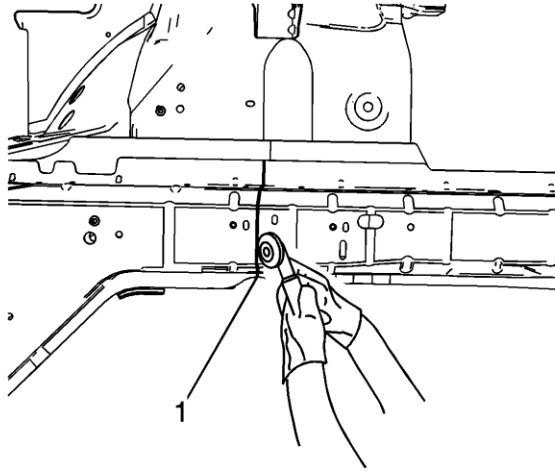
**Note:** Do not damage any inner panels or reinforcements.

8. Cut the panel where sectioning is to be performed (1).

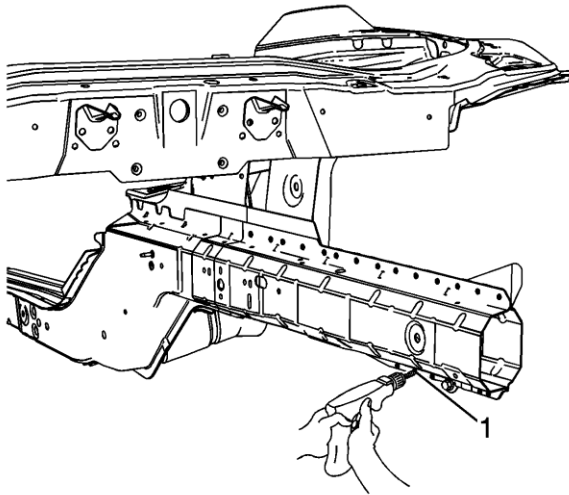
**Note:** Record the number and location of the original welds for installation of the service part.

9. Locate and drill out all factory welds (1).

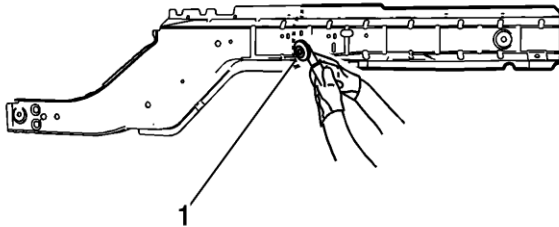
1. Cut the replacement Front Lower Rail in corresponding locations to fit the original panel (1). The sectioning joint should be trimmed to allow 1.5 times the metal thickness at the sectioning joint.

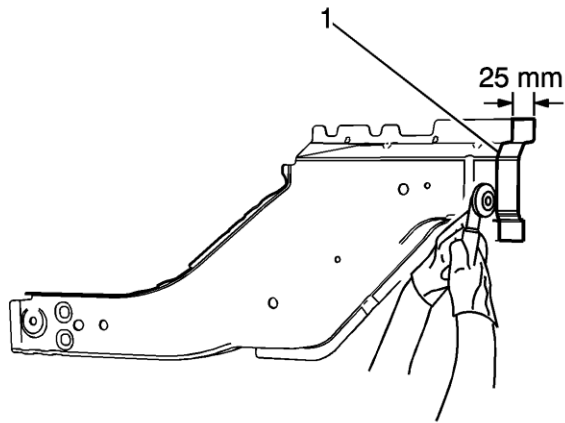
2. Create a 25 mm (1 in) backing plate from the unused portion of the service part (1). Trim the backing plate as necessary to fit behind the sectioning joint.

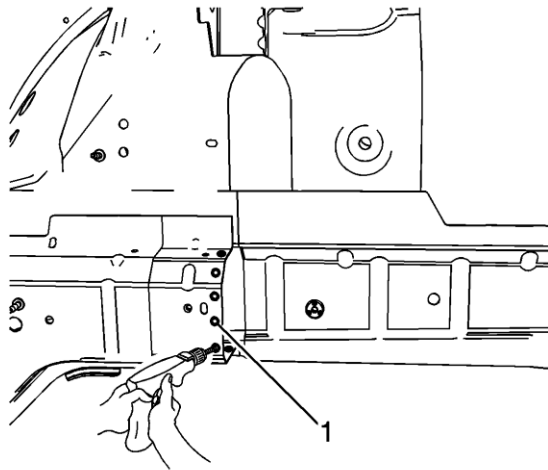
3. Drill 8 mm plug weld holes along the sectioning cut on the remaining original part (1). Space these holes 40 mm apart.

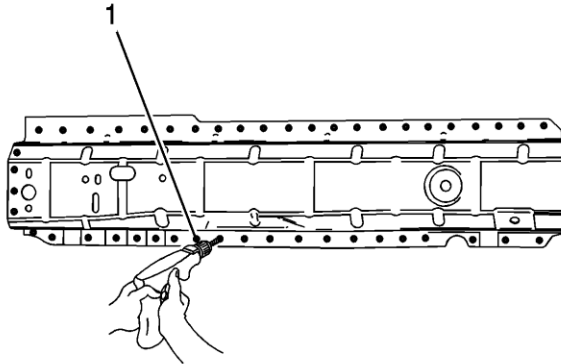
**Note:** In any area damaged beyond recognition, space plug weld holes every 40 mm (1.5 in) apart.

4. Drill 8 mm plug weld holes in the service part as necessary in the locations noted from the original panel and along the sectioning cut (1).
5. Prepare all attached surfaces as necessary for welding.
6. Apply GM approved Weld-Thru Coating or equivalent to all mating surfaces. Refer to [Anti-Corrosion Treatment and Repair](#).

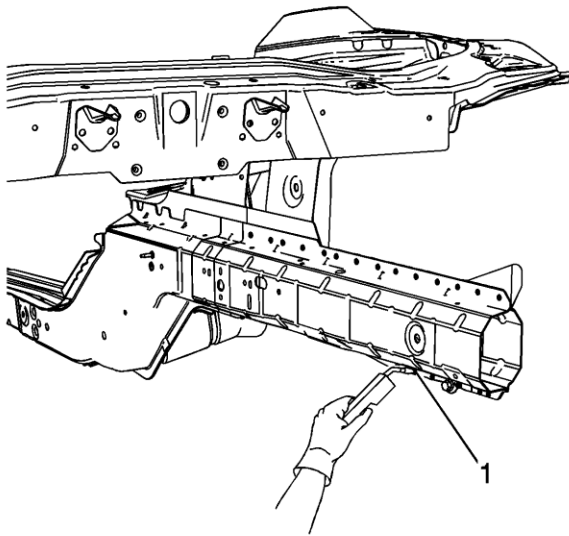
8. Position the Service Front Lower Rail to the vehicle.
9. Plug weld accordingly (1).

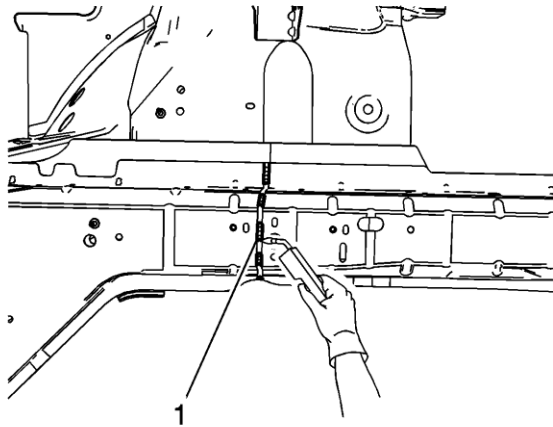
**Note:** To create a solid weld with minimum heat distortion make 25 mm stitch welds along the seam with 25 mm gaps between them. Then go back and complete the stitch weld.

10. Stitch weld sectioning joint (1).
11. Clean and prepare all welding surfaces.
12. Apply the sealers and anti-corrosion materials to the repair area, as necessary. Refer to [Anti-Corrosion Treatment and Repair](#).
13. Paint the repair area. Refer to [Basecoat/Clearcoat Paint Systems](#).
14. Install all related panels and components.
