Quarter Inner Panel Replacement

Removal Procedure

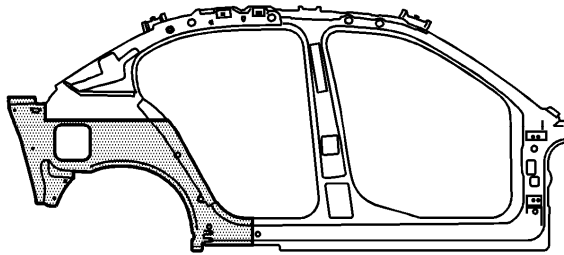
Caution: Sectioning should be performed only in the recommended areas. Failure to do so may compromise the structural integrity of the vehicle and cause personal injury if the vehicle is in a collision.

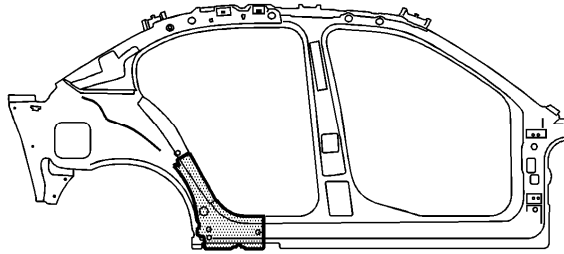
6. Remove the body inner reinforcement.

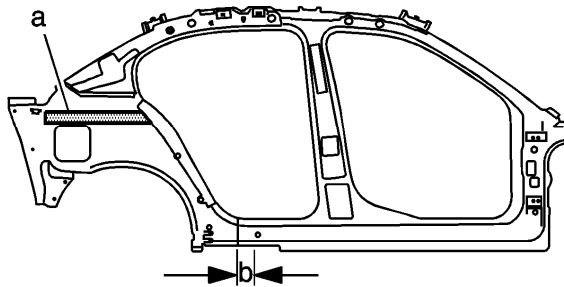
Important: Do not damage any inner panels or reinforcements.

7. Apply a piece of 50 mm (2 in) tape (a) along the flat area above the outer wheel housing, just below the package shelf mating surface, as shown. This is your sectioning location.
8. In the rocker panel area, measure 40 mm (1.5 in) rearward from the rear 25 mm locating hole as shown (b) . Scribe a line. This is your sectioning location.

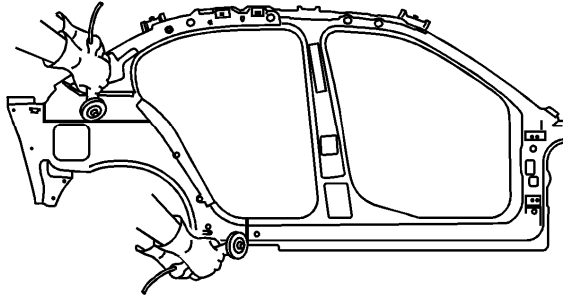
9. Cut the panel to be sectioned.

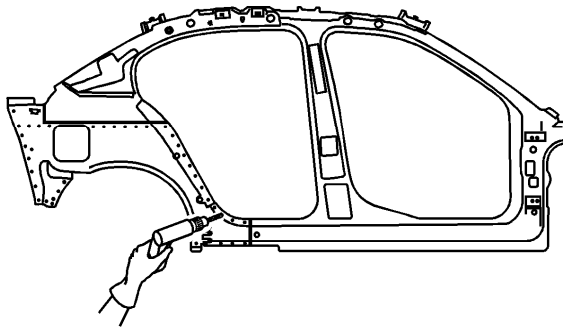
Important: Note the number and location of the factory welds for installation of the inner quarter panel.

10. Locate, mark, and drill out all the necessary factory welds.

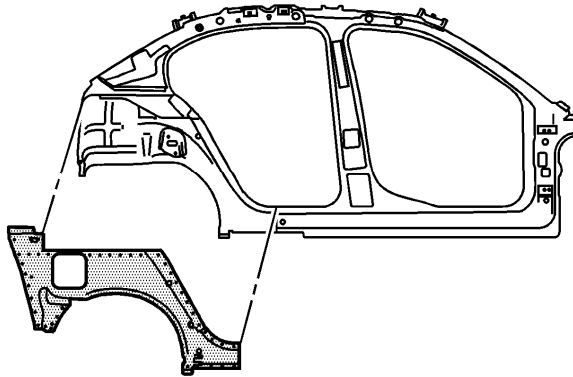
11. Remove the damaged wheelhouse section.

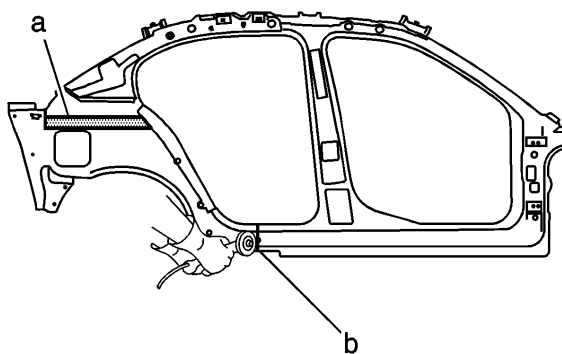
1. Cut the service part in the corresponding locations to the sectioning cuts. Allow for a 50 mm (2 in) overlap at the wheelhouse.

2. Apply 50 mm (2 in) masking tape above the flat area of the wheel house. Cut on the top edge of the masking tape (a) to correspond with the mating surface of the package shelf extension.
3. Scribe a line. Cut the panel (b) in a straight vertical line through the 25 mm locating hole.

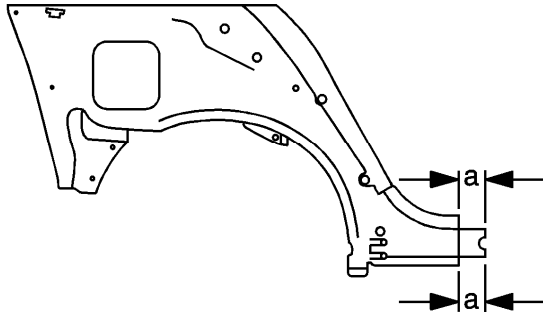
4. At the cut edge of the service rocker panel, measure rearward 50 mm (2 in) (a). Notch out the rocker panel flange to allow the underlap to the extension rocker.

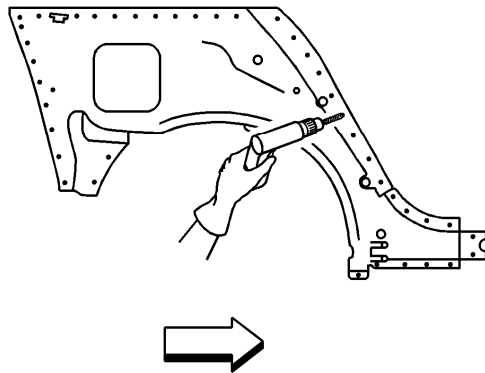
5. Drill 8 mm (5/16 in) plug weld holes along the sectioning cut on the original reinforcement. Locate these holes 25 mm (1 in) from the edge and spaced 40 mm (1½ in) apart.

Important: If the location of the original plug weld holes can not be determined, space the plug weld holes every 40 mm (1 1/2 in) apart.

6. Drill 8 mm (5/16 in) plug weld holes in the service reinforcement as necessary in the locations noted from the original panel.
7. Prepare all mating surfaces as necessary.
8. Apply GM-approved Weld-Thru Coating or equivalent to all mating surfaces.
Refer to [Anti-Corrosion Treatment and Repair](#).

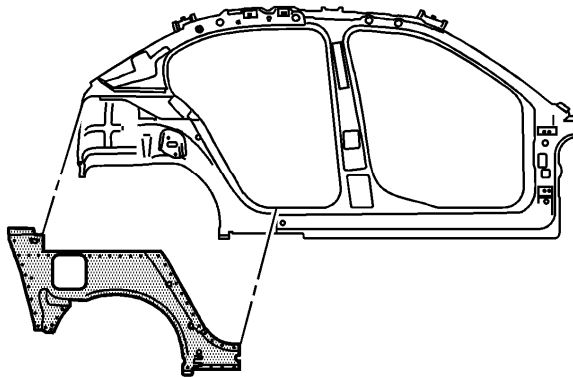
9. Align the service part on the vehicle using 3-dimensional measuring equipment.

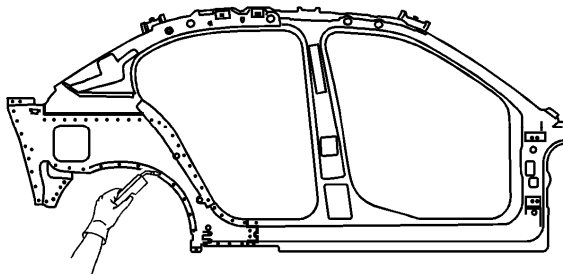
10. Plug weld accordingly.

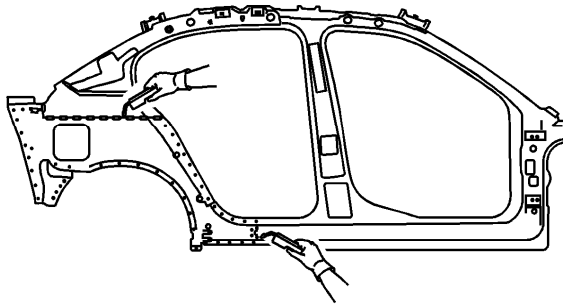
11. To create a solid weld with minimum heat distortion, make 25 mm (1 in) stitch welds along the seam with 25 mm (1 in) gaps between them. Go back and complete the stitch weld.

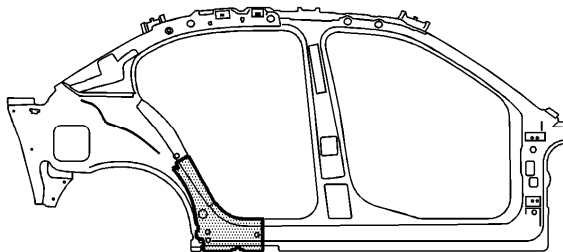
12. Install the body inner reinforcement.
