# Rear Compartment Panel Sectioning

## Removal Procedure

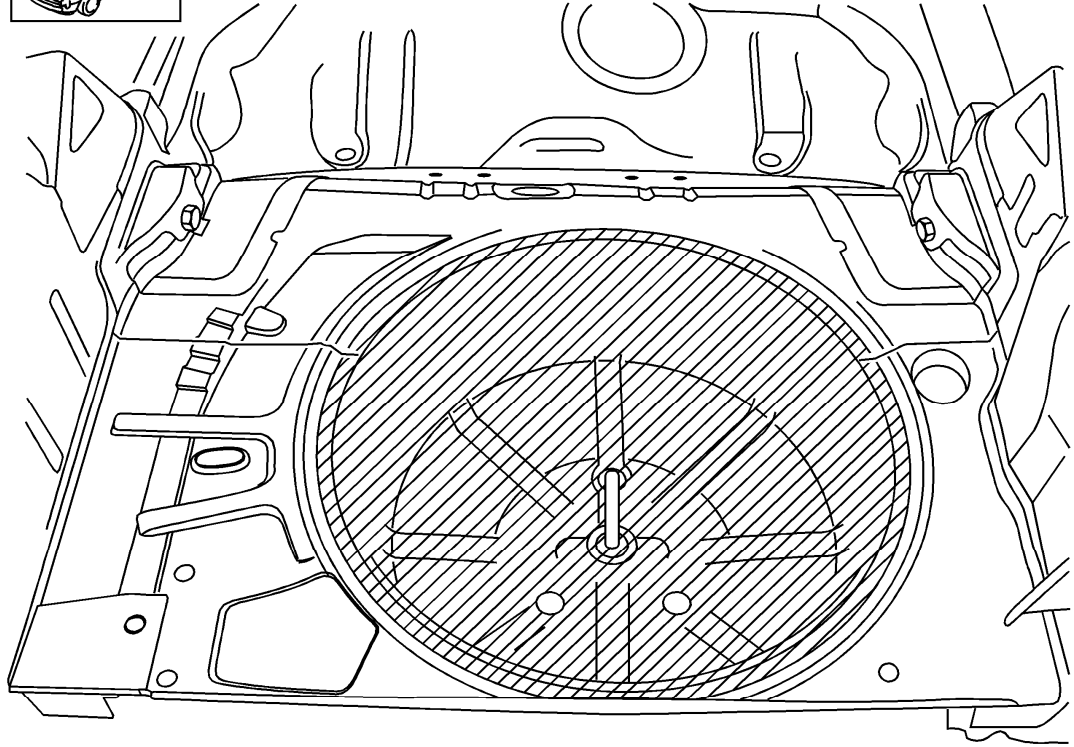
6. Locate and drill out the welds securing the spare wheel well panel.
7. Locate and cut MIG braze weld.
8. Remove the spare wheel well panel.

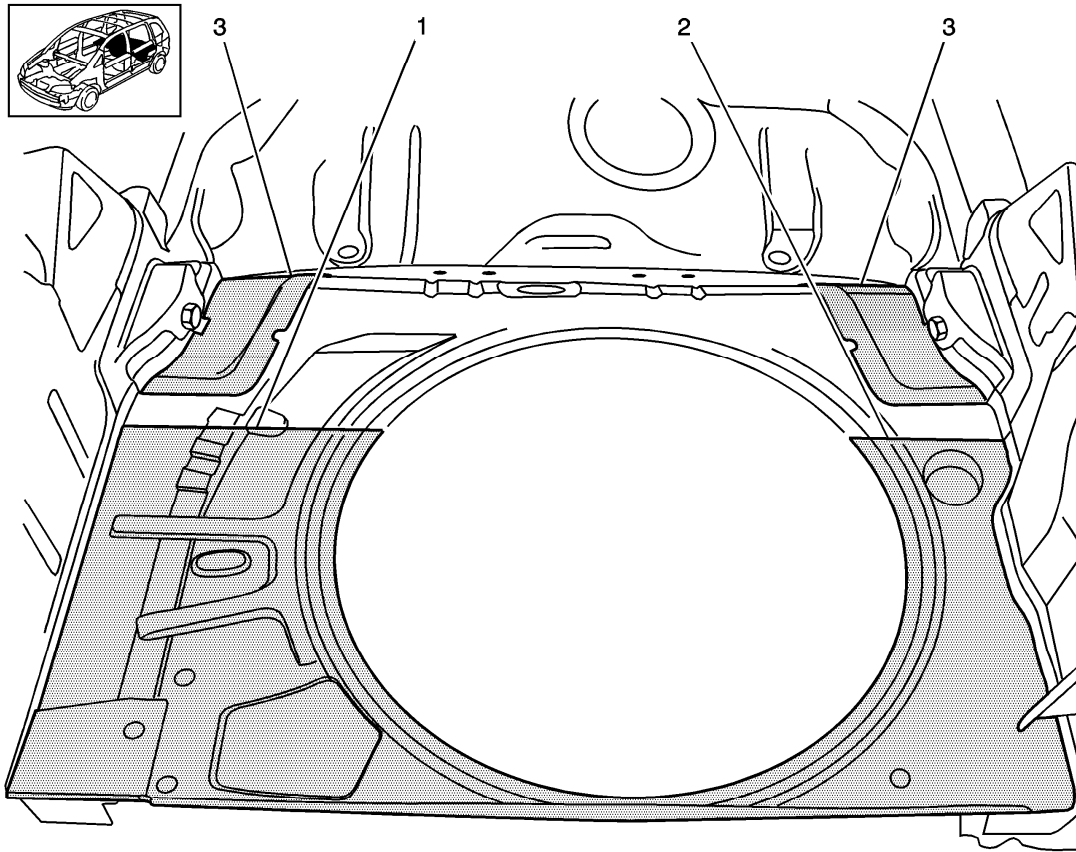
**Important:** Do not damage any inner panels or reinforcements.

9. Cut the rear compartment panel in locations (1) and (2), which are approximately 60 mm (2.5 in) from the floor reinforcements (3).

**Important:** The rear floor sectioning procedure will be an overlap joint just rearward of the floor reinforcements. The service replacement panel comes as a complete assembly and will have to be cut in corresponding locations to complete the repair.

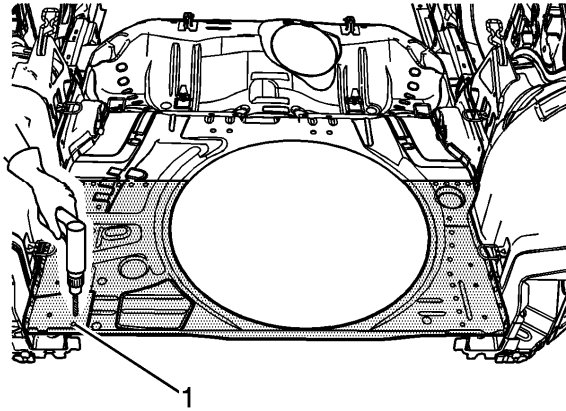
10. Locate and drill out all the factory welds (1) along the top of the floor panel. Note the number and location of the welds for installation.

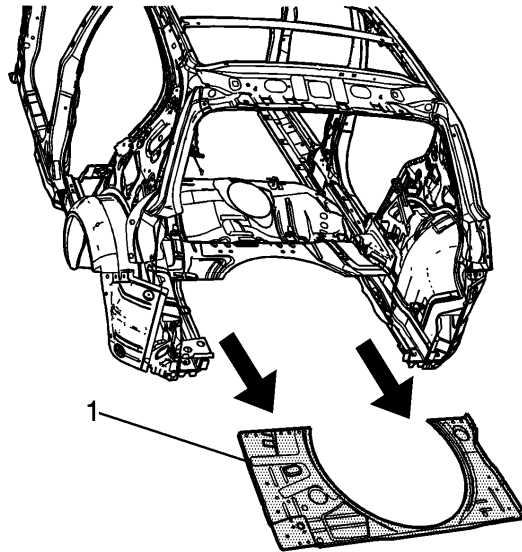
11. Remove the damaged floor panel (1) from the vehicle.

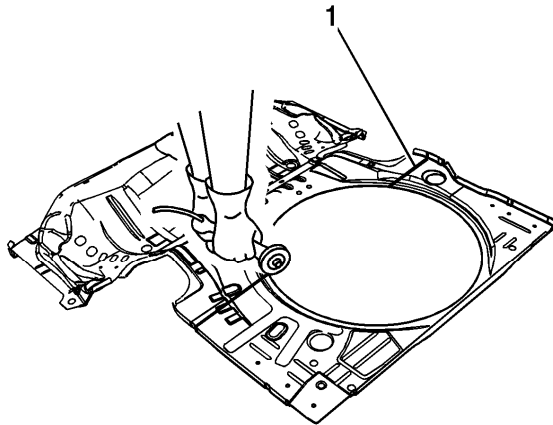
**Important:** When measuring cut location, allow 20 mm extra material for overlap seam.

1. Apply tape to the cut locations (1) based on the original sectioned cut allowing for additional 20 mm for overlap.
2. Section panel as necessary.

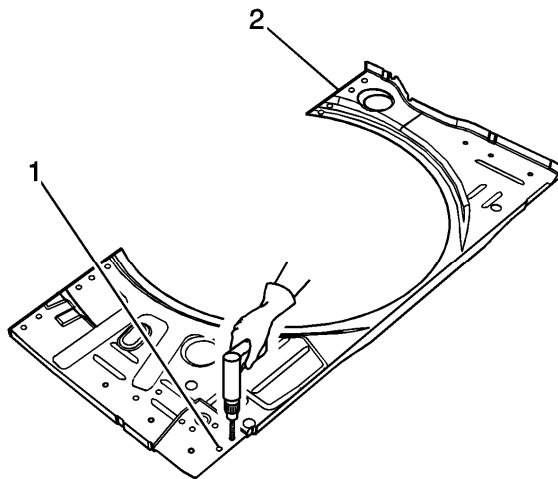
**Important:** If the location of the original welds can not be determined, or if structural adhesive is present, space the plug weld holes every 40 mm (1 in) apart in the service assembly.

3. Drill 8 mm (5/16 in) plug weld holes (1) as necessary in locations noted from the original panel.
4. Drill additional plug weld holes (2) along the overlap edge spaced 40 mm apart.
5. Prepare all mating surfaces as necessary.
6. Apply GM approved Weld-Thru coating or equivalent to all mating surfaces.  
Refer to [Anti-Corrosion Treatment and Repair](#)

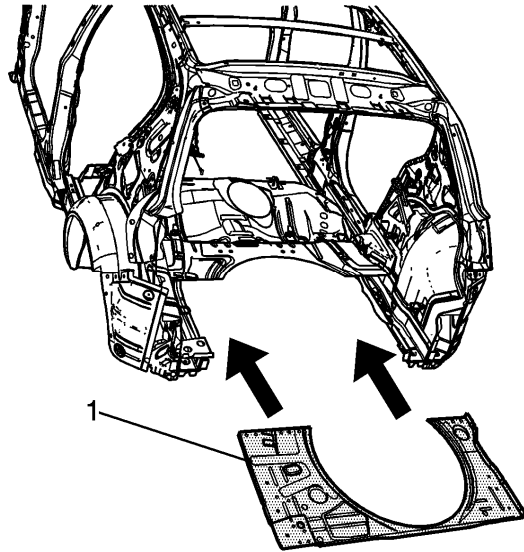
7. Position the service rear panel to overlap the original panel (1). Clamp in place.

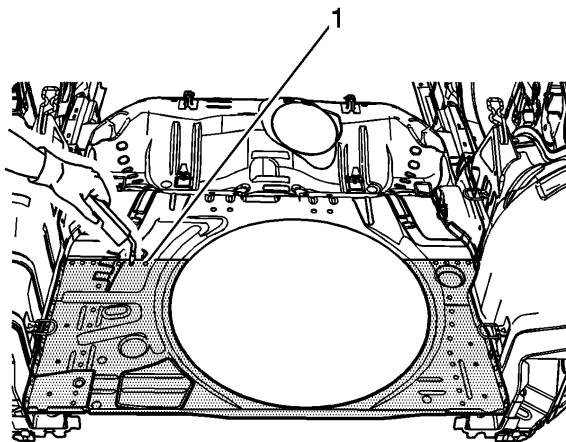
8. Plug weld accordingly.

**Important:** To create a solid weld with minimal heat distortion, make 25 mm stitch welds along the seam with 25 mm gaps between them.

9. Stitch weld the sectioning joint.
  10. Install the rear spare wheel well panel.
  11. Clean and prepare all welded surfaces.
  12. Apply the sealers and anti-corrosion materials to the repair area. Refer to [Anti-Corrosion Treatment and Repair](#) .
  13. Paint the repair area. Refer to [Basecoat/Clearcoat Paint Systems](#) .
  14. Install all related panels and components.
  15. Connect the negative battery cable.
  16. Enable the SIR system.
-
