Rail Underbody Gusset Replacement - Rear

Removal Procedure

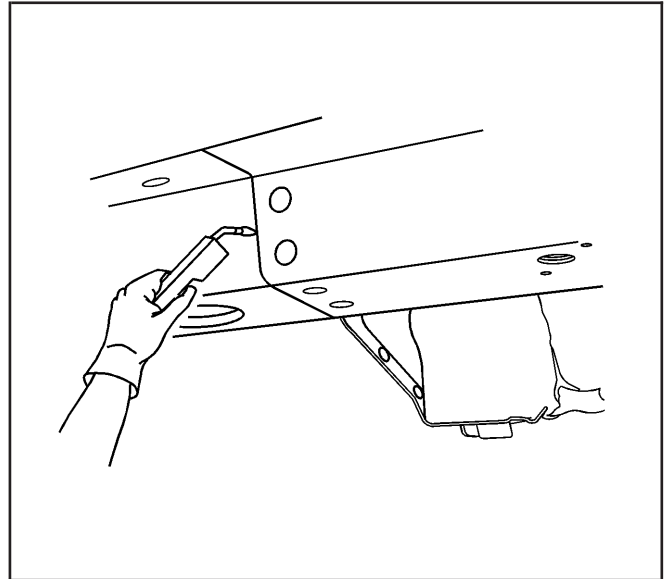
876961

14. Tack weld the part into position.
15. Inspect the service rear rail for proper dimensions, using 3-dimensional measuring equipment.
16. Plug weld at each 8 mm plug weld hole location.
17. Stitch weld along the entire sectioning joint. Make welds along the seam with 25 mm (1 in) gaps between. Weld the gaps.
18. Clean and prepare the welded surfaces.
19. Install all of the related panels and components.
20. Apply the sealers and anti-corrosion materials to the repair area, as necessary.
21. Paint the repaired area.
22. Enable the SIR system.
23. Connect the negative battery cable.

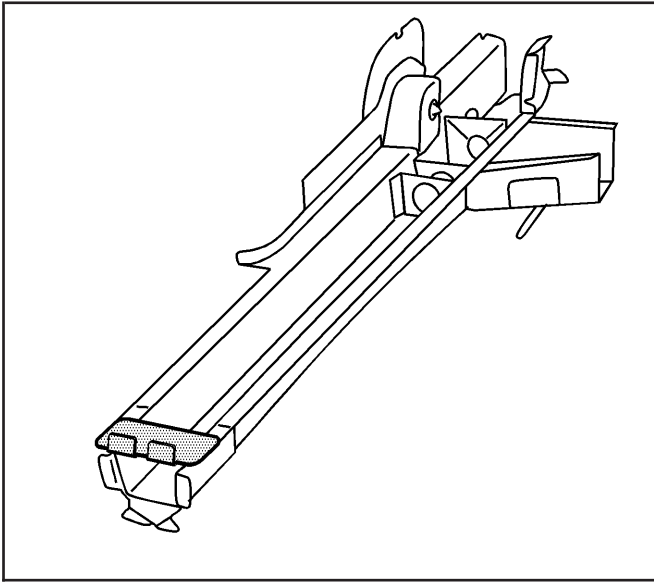
874152

Important: Note the number and location of the factory welds for installation of the underbody gusset to the rear rail.

6. Locate and drill out all the necessary factory welds.

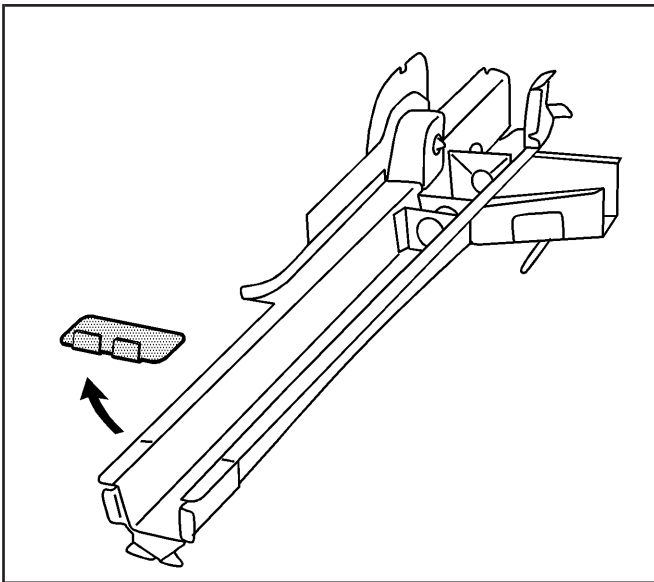
874156

7. Remove the underbody gusset from the rear rail.

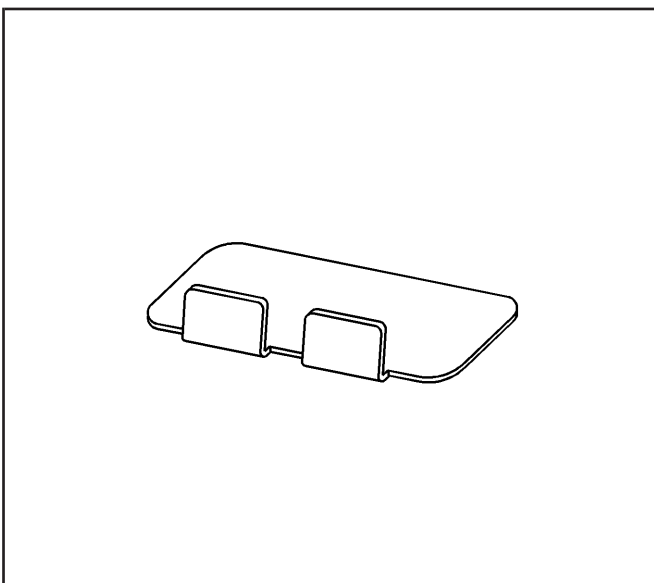
874149

Important: If the location of the original plug weld holes can not be determined, space the plug weld holes every 40 mm (1½ in) apart.

1. Drill 8 mm (5/16 in) plug weld holes in the service part as necessary in the corresponding locations noted on the original panel.
2. Prepare all mating surfaces as necessary.
3. Apply 3M® Weld-Thru coating P/N 05916 or equivalent to all mating surfaces.

4. Position the underbody gusset to the rear rail.

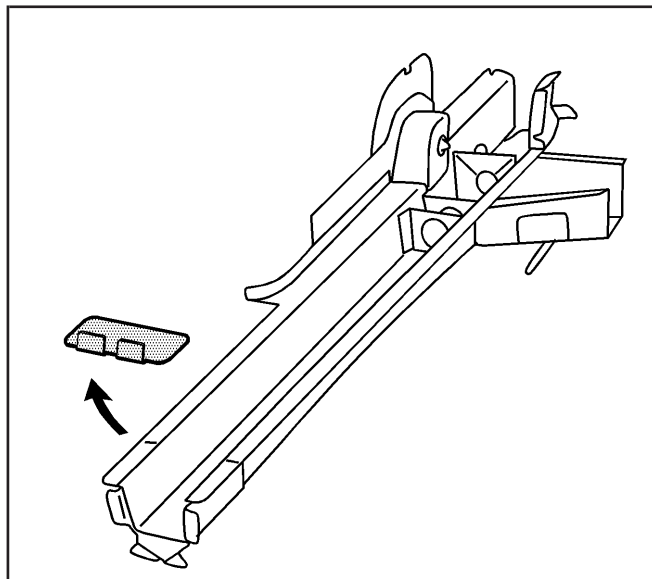
874156

5. Plug weld accordingly.
6. Clean and prepare all of the welded surfaces.
7. Install all of the related panels and components.
8. Apply the sealers and anti-corrosion materials to the repair area, as necessary.
9. Paint the repaired area.
10. Connect the negative battery cable.
11. Enable the SIR system.

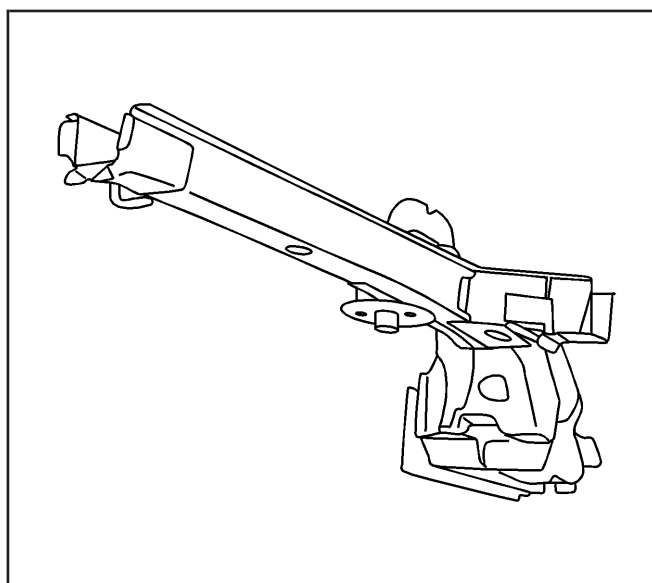
874158

1. Disable the SIR system.
