Floor Panel Replacement

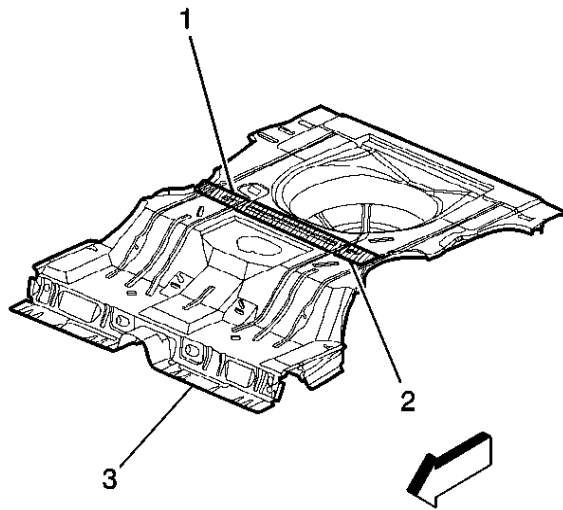
Important: The damaged rear floor is cut along the rearward edge of the rear crossbar (1), and the service part is cut to that the new floor section extends to the forward edge of the rear crossbar (2). This allows the two sections to overlap where the crossbar is attached (2). The service part is supplied as a rear floor assembly (3) which requires cutting to fit. The cut will be about 845 mm (33¼ in) from the rear edge of the forward panel.

Important: Drill out the factory welds rearward of the crossbar only. Do not drill out the welds attaching the floor to the crossbar.

10. Drill out all factory welds.
11. Cut the damaged floor along the rear edge of the crossbar.
12. Do not damage the following components:
 - The rear rails
 - The crossbar
 - The wheelhouse
15. Remove the damaged floor section.

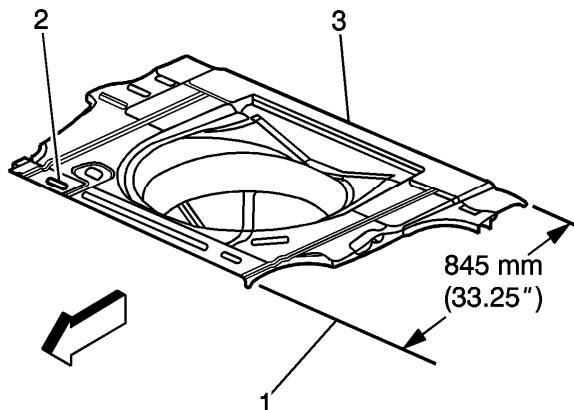
1. Measure 845 mm (33¼ in) from the rear edge of the rear floor service assembly forward and mark the location (1).
2. Prepare the mating surfaces as necessary.

3. Check for proper fit.
4. Allow the floor service assembly (3) to overlap the original floor on top of the rear crossbar (2).
5. Mark the location of the rear rail and crossbar flanges on the bottom of the floor service assembly.

6. Drill 8 mm (5/16 in) plug weld holes as necessary in the locations noted from the original floor assembly.
7. Drill holes approximately 40 mm (1 in) apart where the new floor section attaches to the rear rail and crossbar flanges.
